**THE AIR ACCIDENT INVESTIGATION  
CENTRAL DIRECTORATE**

**FINAL AIRCRAFT SERIOUS INCIDENT REPORT**

<b>AIRCRAFT TYPE</b>	<b>MD 83</b>
<b>REGISTRATION</b>	<b>SU-BOZ</b>
<b>DATE OF OCCURRENCE</b>	<b>23/06/06</b>
<b>LOCATION</b>	<b>Juba Airport</b>
<b>AIRCRAFT LOCATION</b>	<b>N 04 51 54 E 031 36 33.76</b>

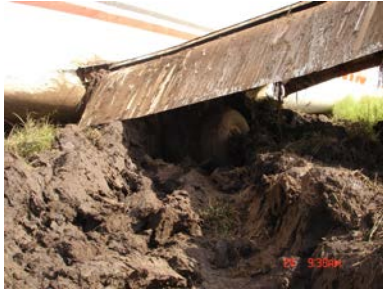
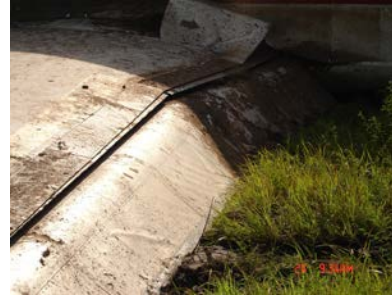
Approximately forty nine seconds after touch down left landing gear actuator sheared off due to a second hard impact and the left landing gear retracted inwards causing left wing to contact the ground forcing flaps to change its setting to 28 degrees. Lateral acceleration imposed and shaking of aircraft and sudden increase of engines EPR above 2 for five seconds, forty three seconds after touch down, that increased aircraft speed puzzled the crew. No one noticed the position of the aircraft within the runway. Reasons for EPR increase might be due to high vibration and shaking of aircraft in addition to PIC holding the throttles which might caused the throttles moving forward unintentionally due to the first hard impact on leaving paved ground. Deployment of reverse for the second time which last for 4 seconds commenced 48 seconds after touch down and at a distance of 1868 meters ( 6129 feet ) from touch down point after landing gear warning horn sound. Deployment of reverse occurred of 69 Kts. with an ineffective brakes which might be due to wear of brake discs and exhausted hydraulic system working on reduced power. Deployment of reverse caused the aircraft to roll for a distance of 175 meters ( 574 feet ) turning the aircraft to 360 heading. The aircraft came to complete stop resting on the extended right gear and left wing resting on the ground.

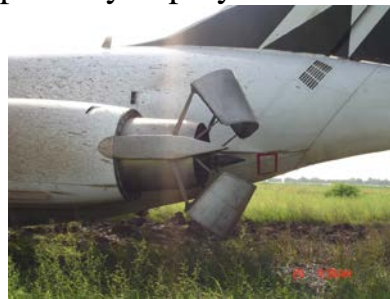
By the time the PIC selected deploying of the reverse the Left hydraulic System thrust reverser accumulator pressure was already being exhausted during first deployment after touch down due to the fact that the left system already lost its hydraulic fluid to atmosphere as the return pipe connection to the reservoir is being damaged due to severe tightening. Operation of brakes was supplied by the right hydraulic system and thrust reverser of the left engine was actuated for the first trial from its accumulators. left engine reverse might not being completely stowed after being deployed at landing due to insufficient available pressure from the left hydraulic system and thus was kept partially deployed. During the second time selection of reverse deployment the Right Hydraulic System fully deployed the right engine reverse and thus the aircraft speed increased due to thrust from the left engine. The aircraft came to stop resting on its belly and left wing touching the ground with right engine reverse doors stowed and that of left engine partially deployed.

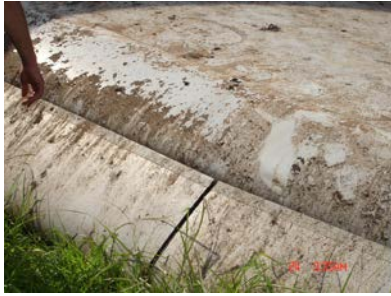
Flaps forced up by ground reaction

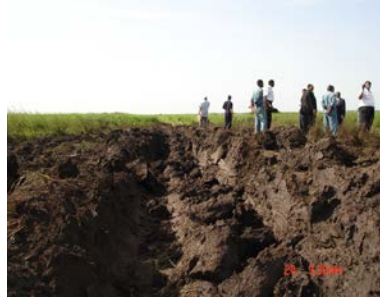
Track of aircraft

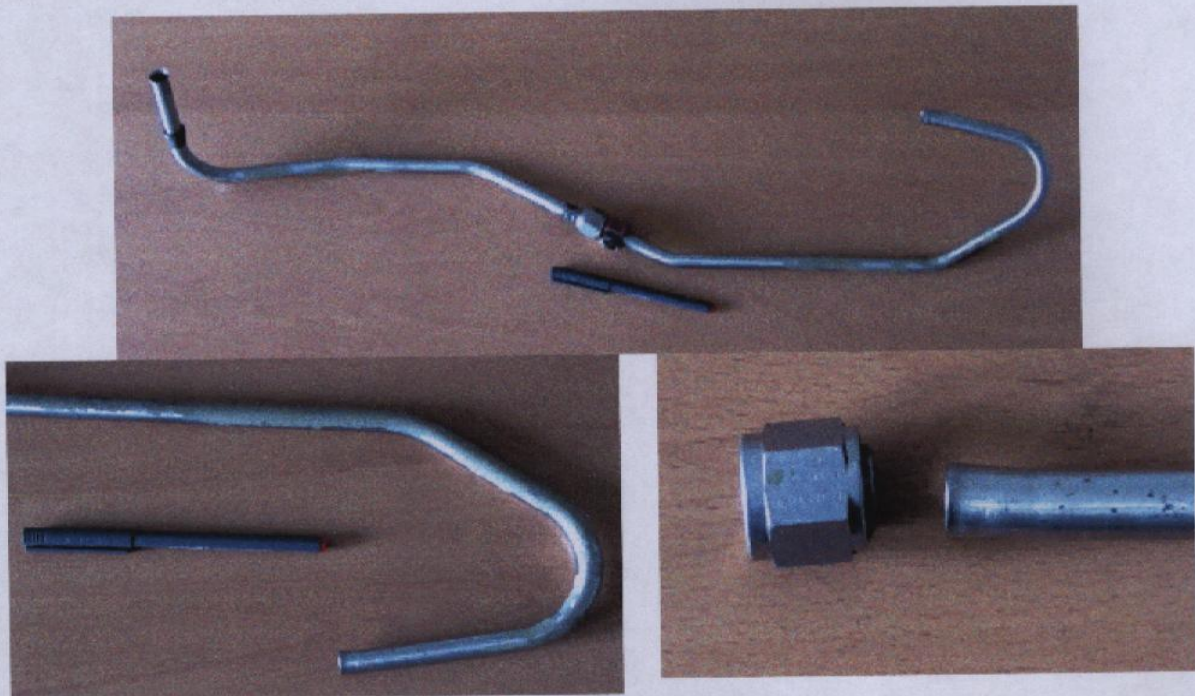
Fig.1 General View of failed pipe

The failed hydraulic pipe is shown in Fig.1. One end is seemed to be flattened due to severe tied force. The surface does not contain any markings typical of cutting or shearing. Detailed investigation of surface from inside and outside of the received pipe showed the presence of deformation strain bands. Therefore, the decision was taken after the approval from Egyptian Ministry of Civil Aviation, to cut specimens in order to carry out further metallurgical analyses on this part. Samples were cut using automatic (slow speed) cutting machined cooled by water jet.

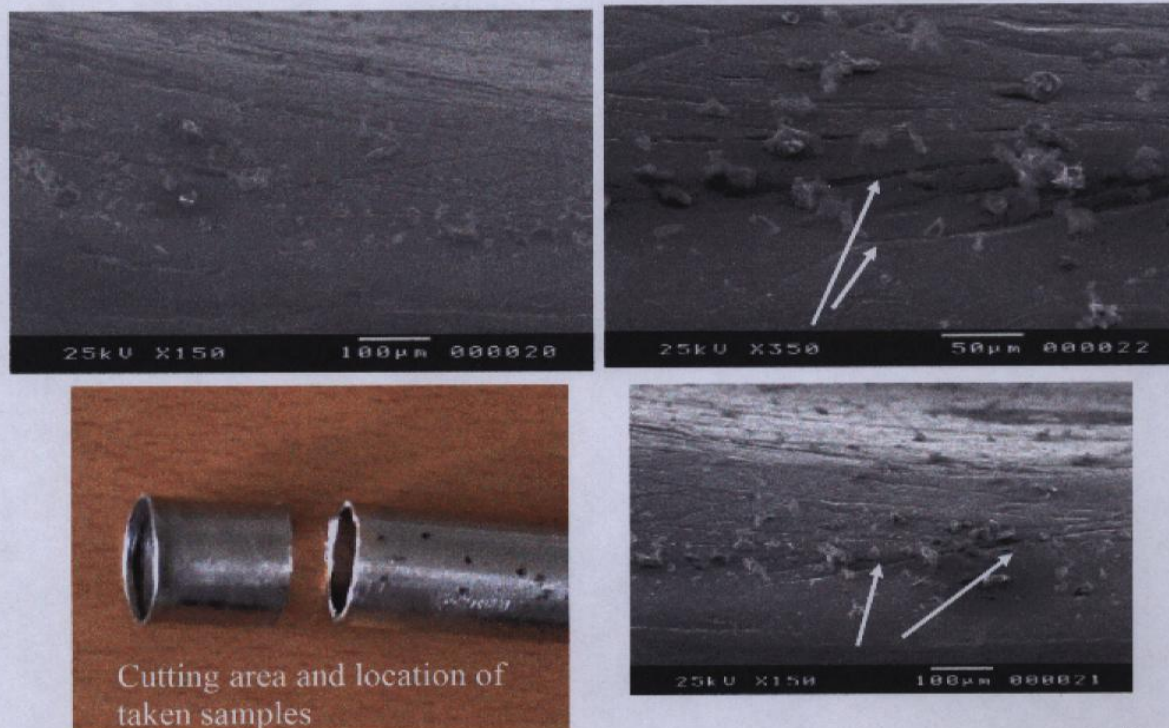
Fig. 2 Strain hardening bands – general view

Close-up investigation by SEM was carried out and the results are shown in Fig.2. Generally, the presence of such strain hardening bands revealed the occurrence of plastic deformation which could be resulted from the over tightening during the regular check up by the workers.

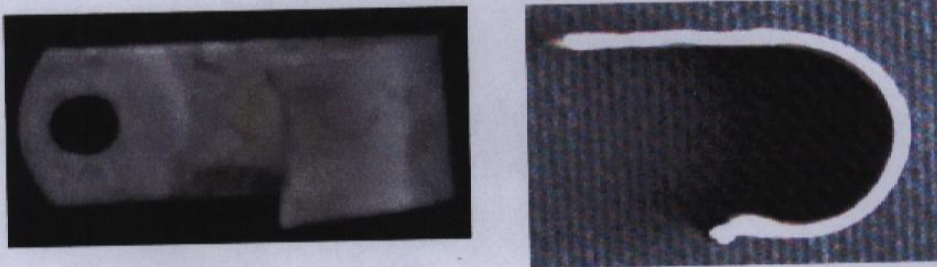
Fig.3 General view of fracture clip

The failed hydraulic pipe is shown in Fig.3. The other part of the clip was lost during the accident. The fracture surface does not contain any markings of typical fatigue or shearing failure. Detailed investigation of surface showed the presence of voids or dimple fracture.

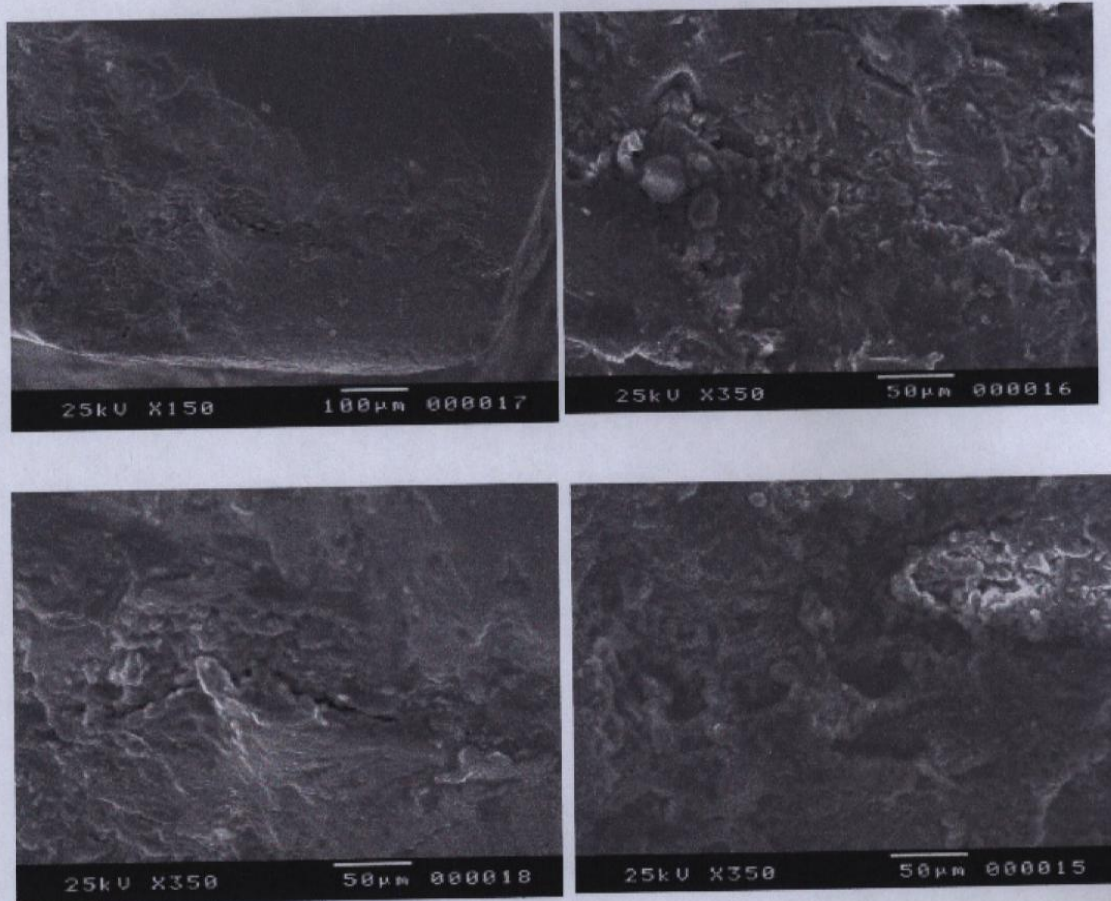
Fig. 4 General overview of the fracture surface showing voids formation due to the presence of nonmetallic particles.

The general view of the fracture surface that investigated by using SEM is shown in Fig. 4. The fracture surface is characterized by microvoid coalescence. The microvoids nucleate at regions of localized strain discontinuity, such as that associated with second phase particles. As the strain in the material increases, the microvoids grow, coalesce, and eventually form a continuous fracture surface. This type of fracture exhibits numerous cuplike depressions that are the direct result of

the microvoid coalescence. The cuplike depressions are referred to as dimples, and the fracture mode is known as dimple fracture.

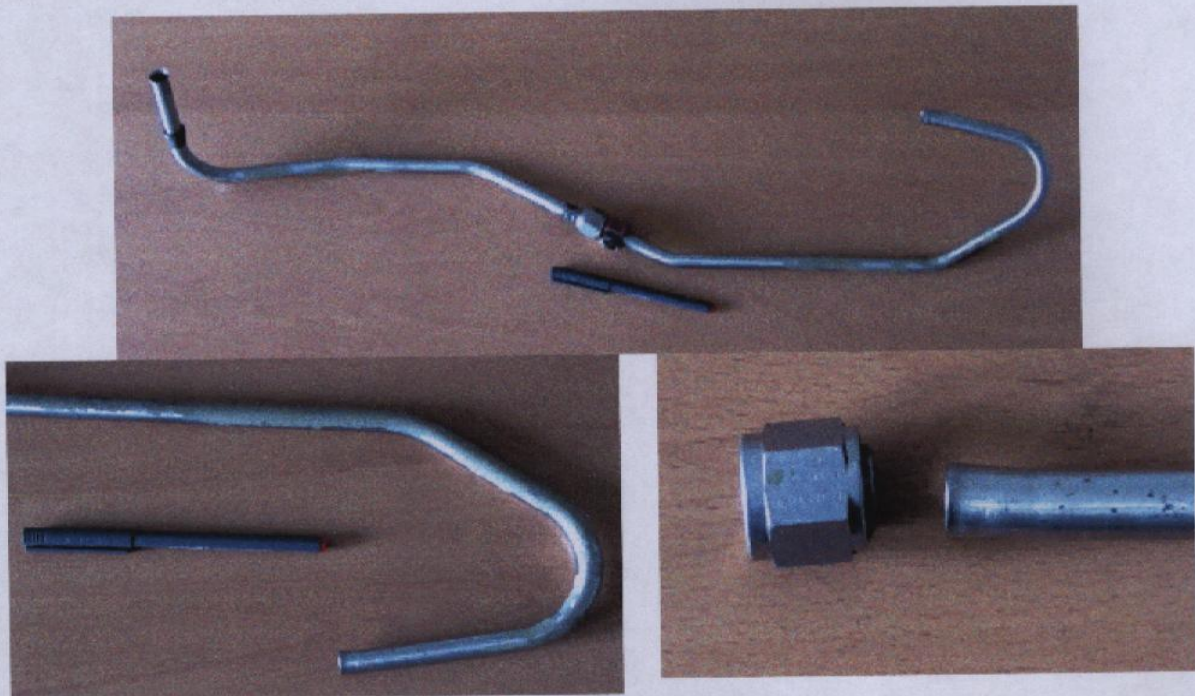
Fig.1 General View of failed pipe

The failed hydraulic pipe is shown in Fig.1. One end is seemed to be flattened due to severe tied force. The surface does not contain any markings typical of cutting or shearing. Detailed investigation of surface from inside and outside of the received pipe showed the presence of deformation strain bands. Therefore, the decision was taken after the approval from Egyptian Ministry of Civil Aviation, to cut specimens in order to carry out further metallurgical analyses on this part. Samples were cut using automatic (slow speed) cutting machined cooled by water jet.

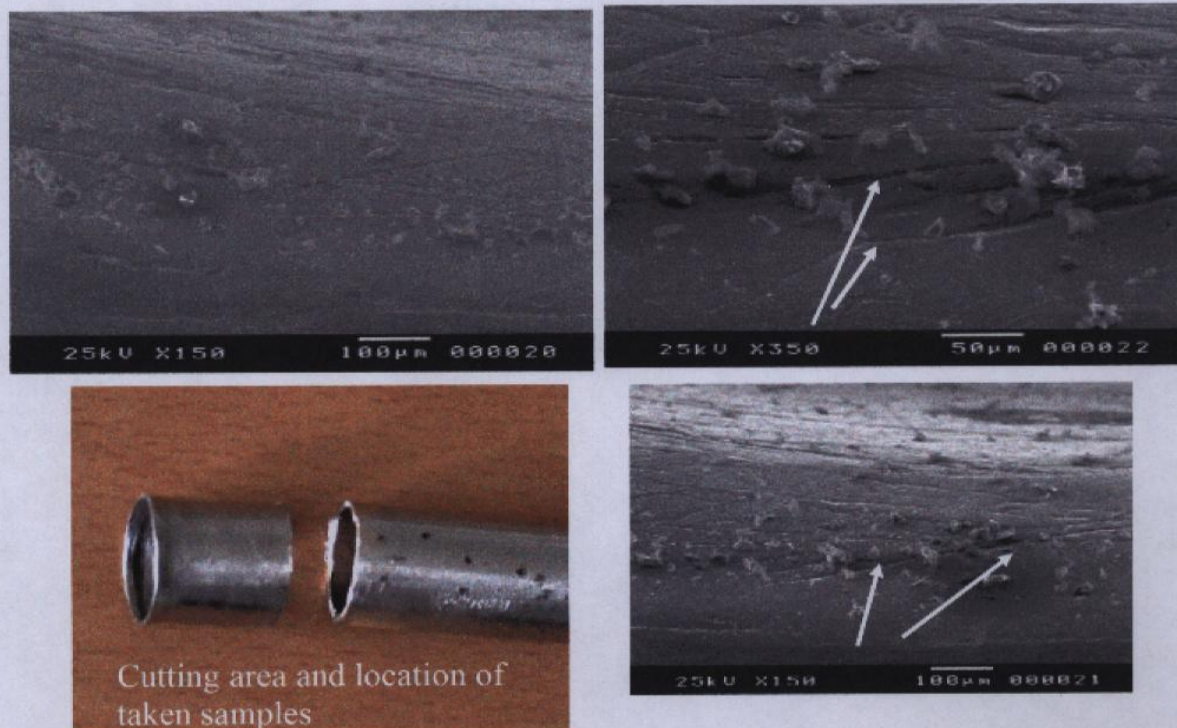
Fig. 2 Strain hardening bands – general view

Close-up investigation by SEM was carried out and the results are shown in Fig.2. Generally, the presence of such strain hardening bands revealed the occurrence of plastic deformation which could be resulted from the over tightening during the regular check up by the workers.

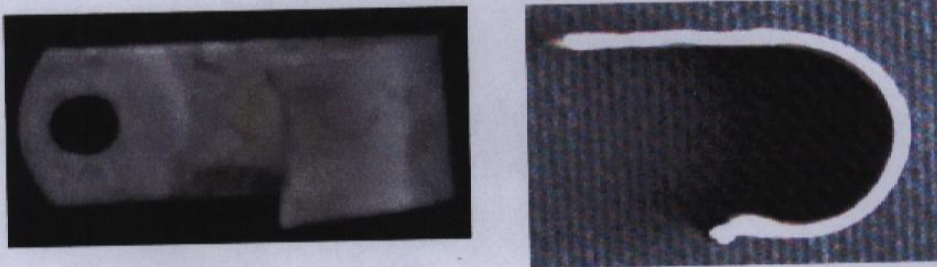
Fig.3 General view of fracture clip

The failed hydraulic pipe is shown in Fig.3. The other part of the clip was lost during the accident. The fracture surface does not contain any markings of typical fatigue or shearing failure. Detailed investigation of surface showed the presence of voids or dimple fracture.

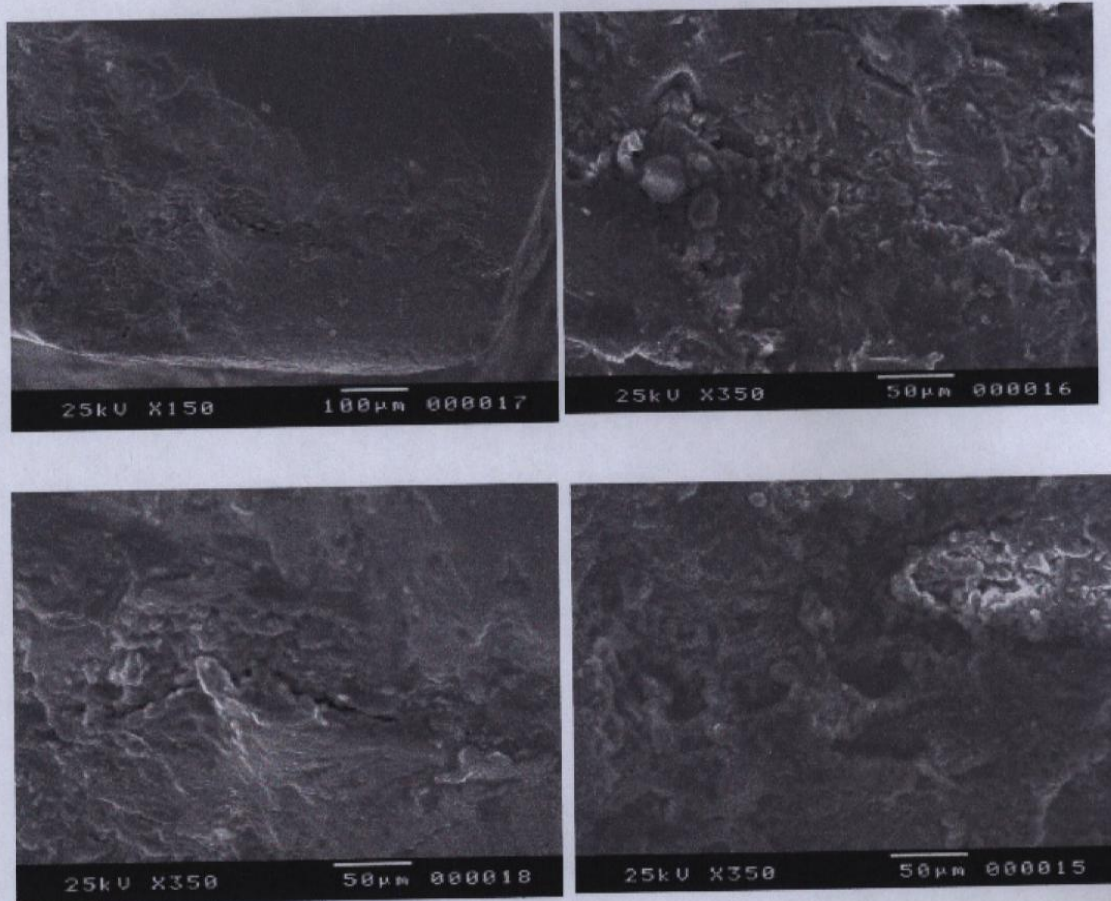
Fig. 4 General overview of the fracture surface showing voids formation due to the presence of nonmetallic particles.

The general view of the fracture surface that investigated by using SEM is shown in Fig. 4. The fracture surface is characterized by microvoid coalescence. The microvoids nucleate at regions of localized strain discontinuity, such as that associated with second phase particles. As the strain in the material increases, the microvoids grow, coalesce, and eventually form a continuous fracture surface. This type of fracture exhibits numerous cuplike depressions that are the direct result of

the microvoid coalescence. The cuplike depressions are referred to as dimples, and the fracture mode is known as dimple fracture.
